Transportation Research Interdisciplinary Perspectives

A field study of sensors for winter road assessment

Tanita Fossli Brustad^{*}, Aleksander Pedersen, Børre Bang

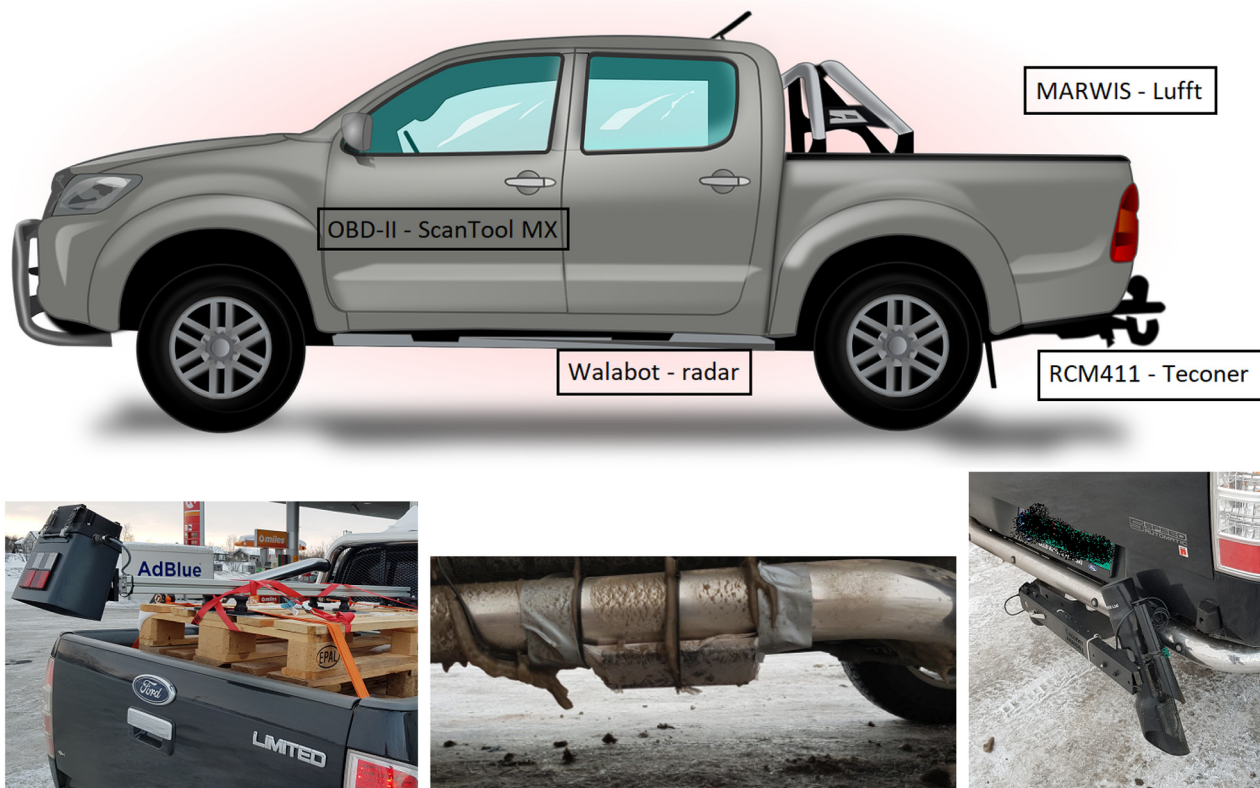
Fig. 2. Placement of the sensors on the car. Top image by OpenClipart-Vectors from Pixabay.

The sensor setup on the vehicle, seen in Fig. 2, was done in the following way: the RCM411 sensor was mounted on the tow ball pointing at the right wheel track, the MARWIS sensor was secured with a rack to the truck bed pointing at the center of the road behind the vehicle, and the Walabot sensor was attached below the back left passenger door pointing straight down at the wheel track. All sensors were mounted and configured according to their user manual instructions.
